Manhole Inspection Summary

Manhole # S65S__005MH

Insp Date: **3/11/08 9:59 AM**

Location Address: **1550 El Rino St.**

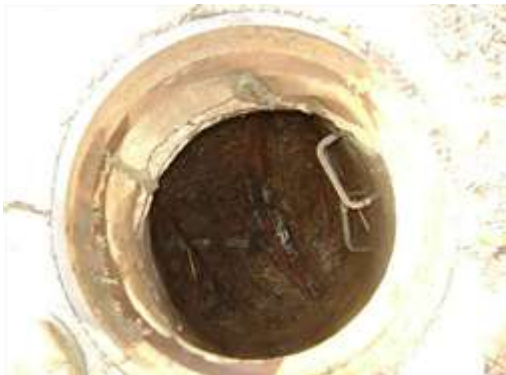
Frame Offset: **3** (in.) Condition: ☒ Sound ☐ Cracked ☐ Leaks

Offset frame

Offset frame defect

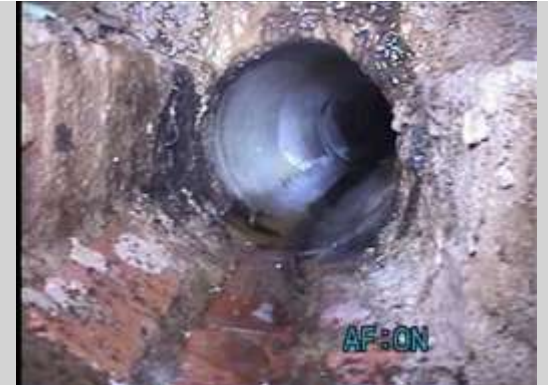
12 O'Clock Outflow

8 in. Circular Gravity Sewer
Pipe Out @ 12 O'Clock

Pipe Height: **8.4** (in.) Rod and Bar (Angled)
Pipe Material: **Clay** ☐ Pipe Lined
Invert Depth: **7.38** (ft.) Flow Characteristics: **Slow**
Deposits: ☐ None ☐ Mud ☐ Sludge ☒ **Debris** ☒ **Grease**
Silt Depth: **0.5** (in.) Deposits Extent: **Light**
Infiltration: **None** Pipe Seal Cond: **Sound**

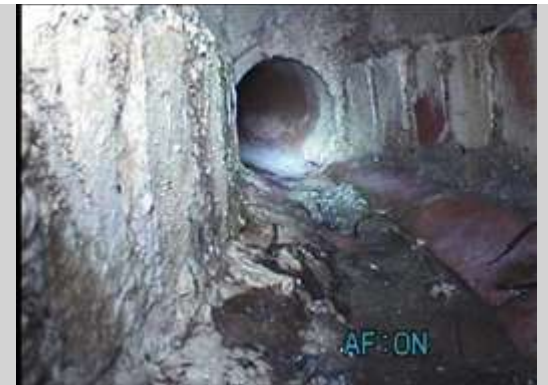
5 O'Clock Inflow

6 in. Circular Gravity Sewer
Pipe In @ 5 O'Clock

Pipe Height: **6** (in.) Rod and Bar (Angled)
Pipe Material: **Clay** ☐ Pipe Lined
Invert Depth: **7.21** (ft.) Flow Characteristics: **None**
Deposits: ☐ None ☐ Mud ☐ Sludge ☒ **Debris** ☐ Grease
Silt Depth: **0.5** (in.) Deposits Extent: **Light**
Infiltration: **None** Pipe Seal Cond: **Sound**
